# Manhole Inspection Summary

Manhole # S17II\_012MH

Insp Date: **6/12/07 8:48 AM**

**Location** Address: **1812 SMALLWOOD-BENTALOU**

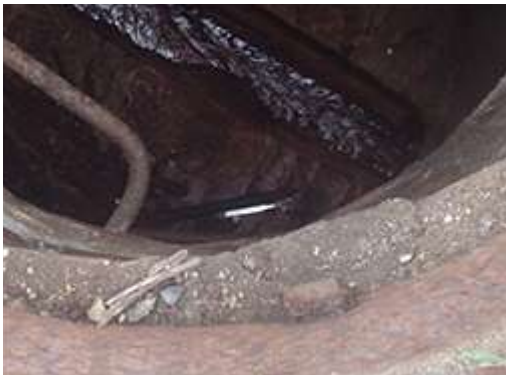
Defect 4

Offset: **1** (in.)

FRAME OFFSET

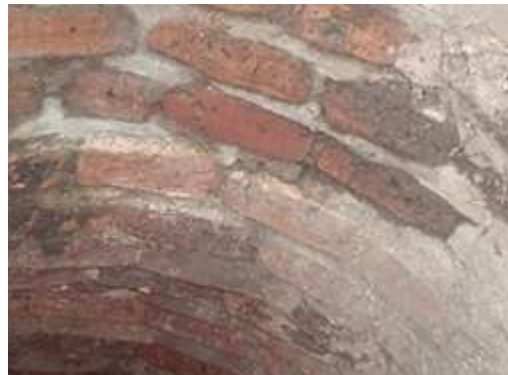
Defect 3

Condition: ☐ Sound ☐ Cracked ☐ Root Intrusion ☐ Loose Brick ☒ **Deteriorated**

DETERIORATION OF CORBEL

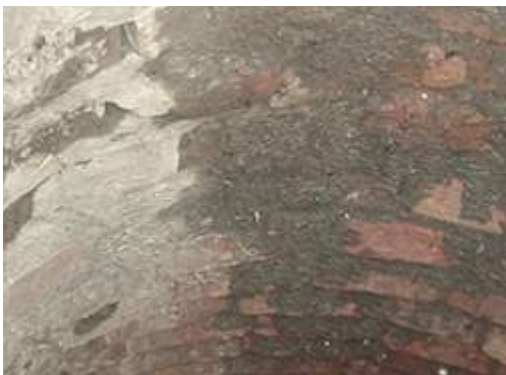
Defect 2

Infiltration: ☐ None ☐ Joint ☐ Cracks ☐ Mortar ☐ Roots ☒ **Wall**

INFILTRATION OF CHIMNEY WALL

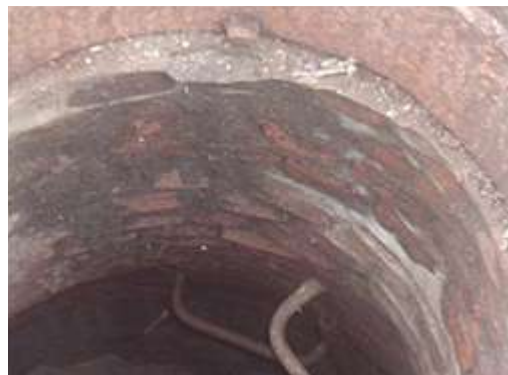
Defect 1

Condition: ☐ Sound ☐ Cracked ☐ Root Intrusion ☐ Loose Brick ☒ **Deteriorated**

DETERIORATION OF CHIMNEY
